TECHNICAL INFORMATION SHEET TIS1002 – Dec 2008

ROLLER CONTACT UPGRADE FOR ATL “AT” ON-LOAD TAPCHANGERS

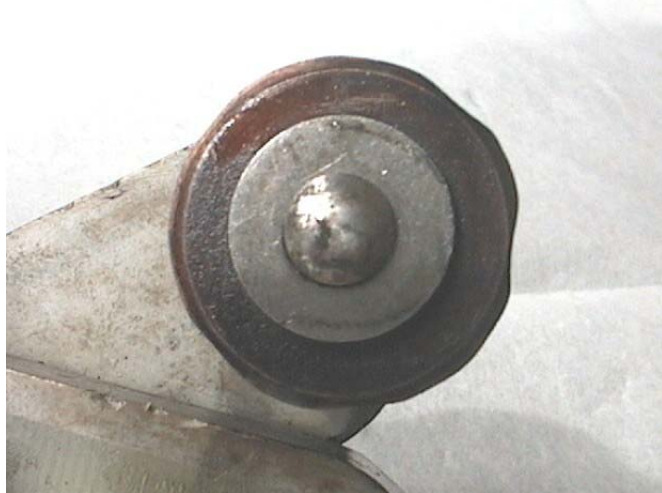
Early model Associated Tapchangers Limited (ATL) type AT tapchangers may exhibit signs of uneven erosion on the transitional roller contacts in the form of crescent shaped depressions - see photo. This can be caused by the rollers not rotating to present a new face for each make/break operation. This can considerably shorten contact life, especially where the step kVA is high (load current x step k.volts), and may lead to other complications if left until the wear pattern is extreme. This tendency is more pronounced if the tapchanger is operating over a limited tapping range, particularly hunting over just two taps.

Original plain roller contact on scissor arm showing signs of uneven wear. The solution to this problem is to upgrade to ratchet rollers.

You may wish to consider upgrading your AT tapchangers by fitting the latest design of transition arcing contacts, which have ratcheted rollers similar to those used for the main arcing contacts. The ratchet mechanism is applied to both the moving scissor rollers and the corresponding fixed contact transition rollers. Pawl springs are added to the fixed transition rollers to provide indexing.

The benefit of this upgrade is that the transition contacts are positively indexed and rotate in one direction only, distributing arc erosion evenly around the circumference of the roller, increasing contact life and reducing the risk of sudden failure.
